APPENDIX C PHOTOGRAPHIC LOG

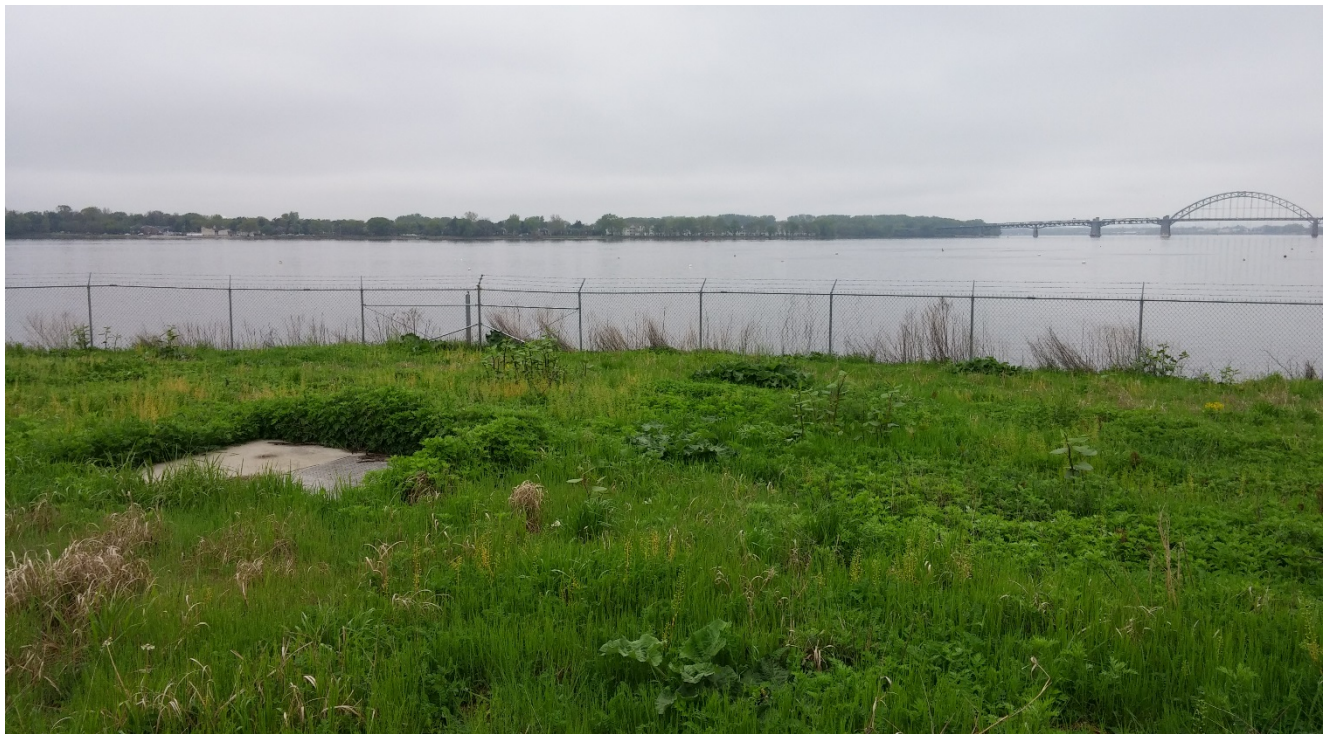
Photo 1: Pre-mobilization site conditions. View of future equipment storage and staging areas, facing southeast.

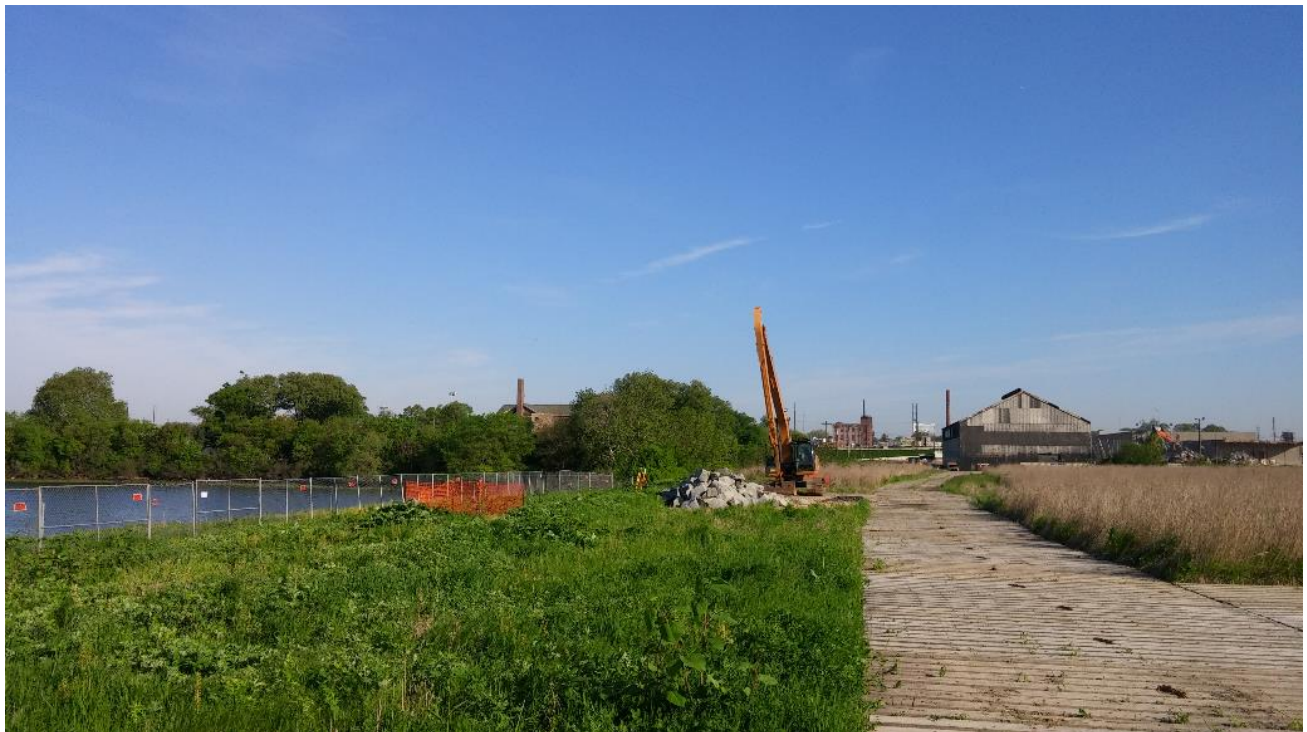
Photo 2: Site access road, equipment staging and R6 material stockpile area, facing west.

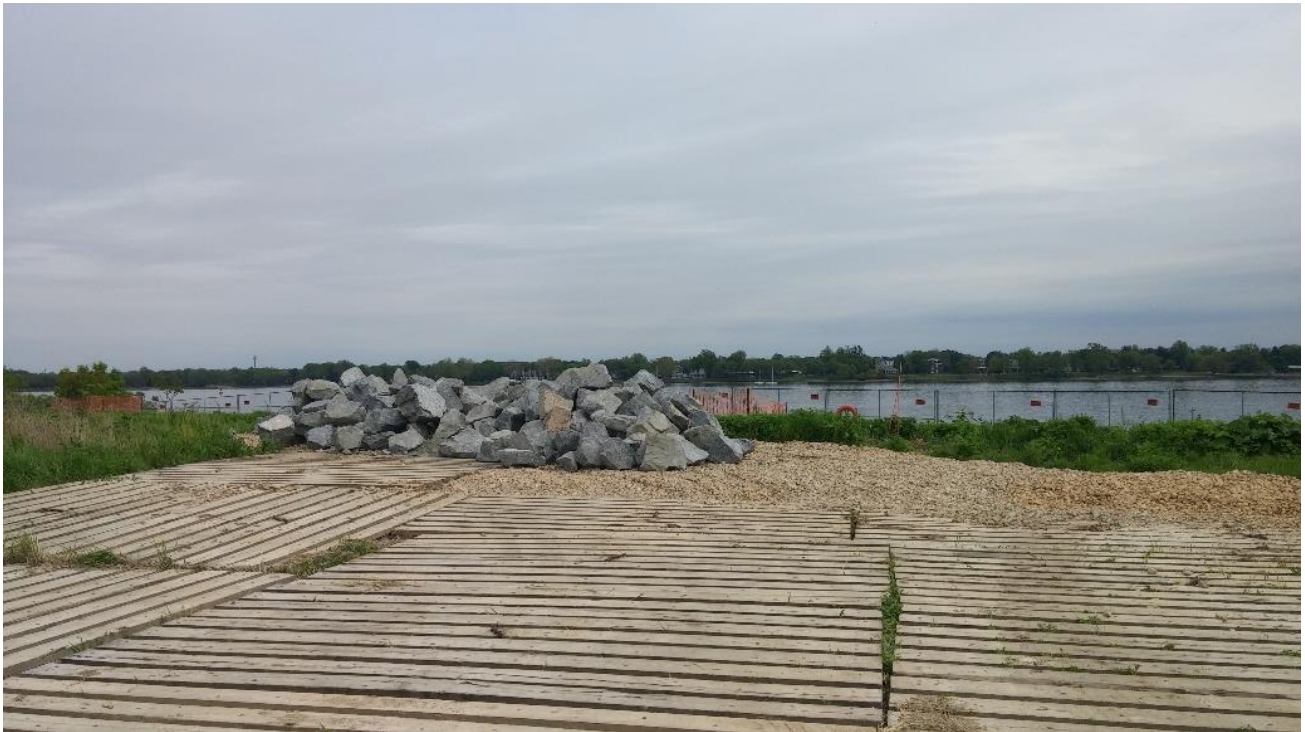
Photo 3: R6 material stockpile on top of crushed stone pad at end of site access road, facing northeast.

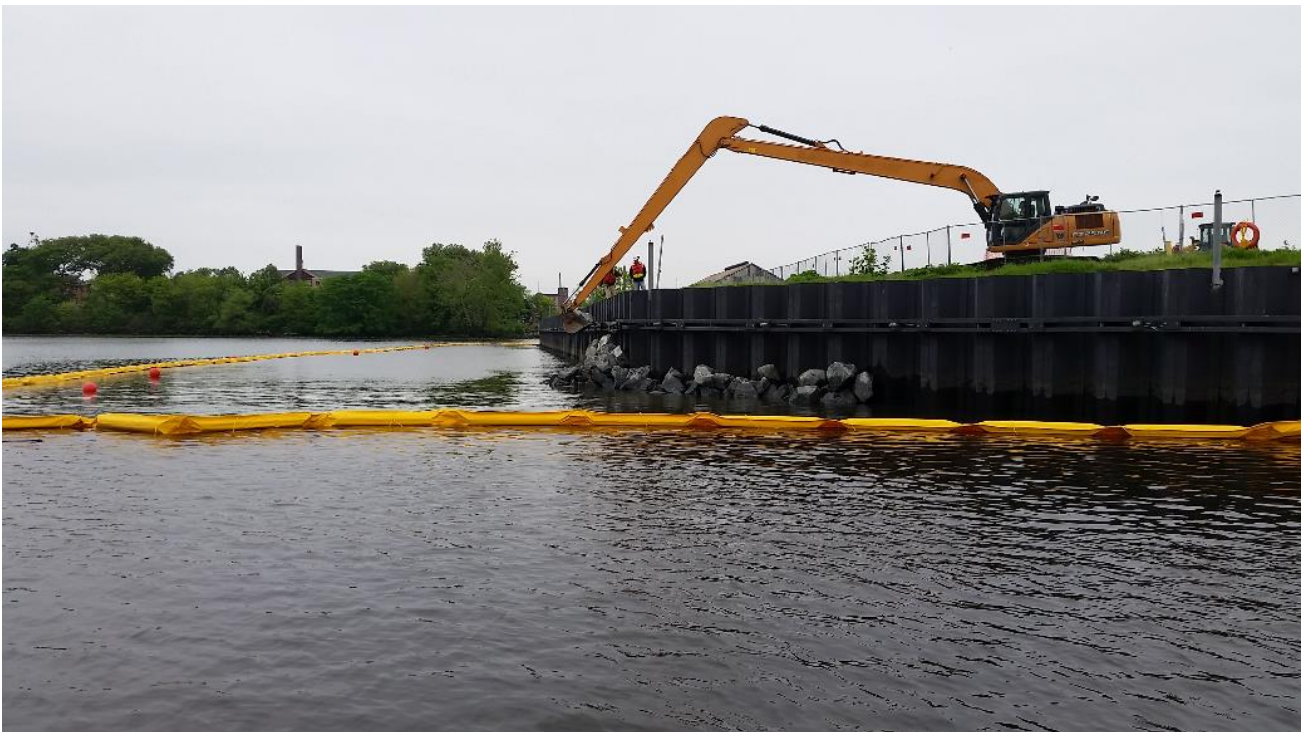
Photo 4: R6 material placement via long-reach excavator, facing west.

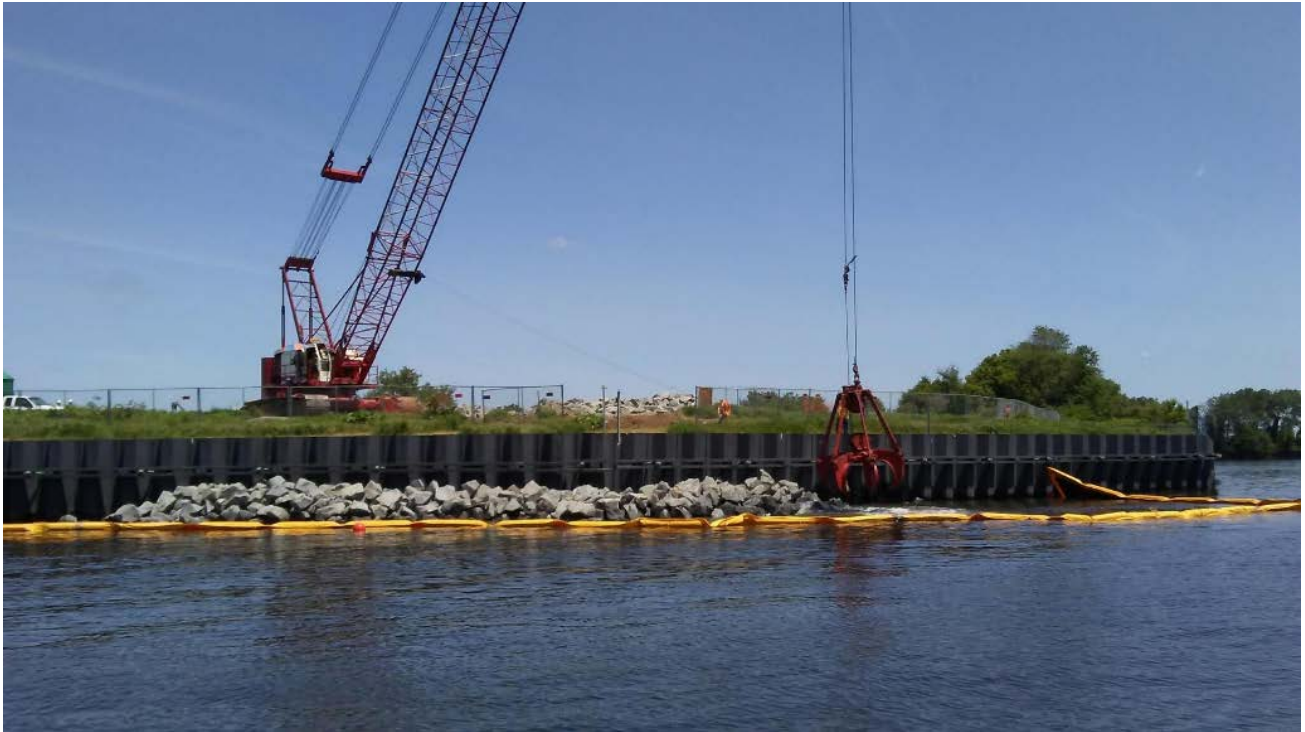
Photo 5: R6 material placement via crane equipped with grapple attachment, facing northwest.

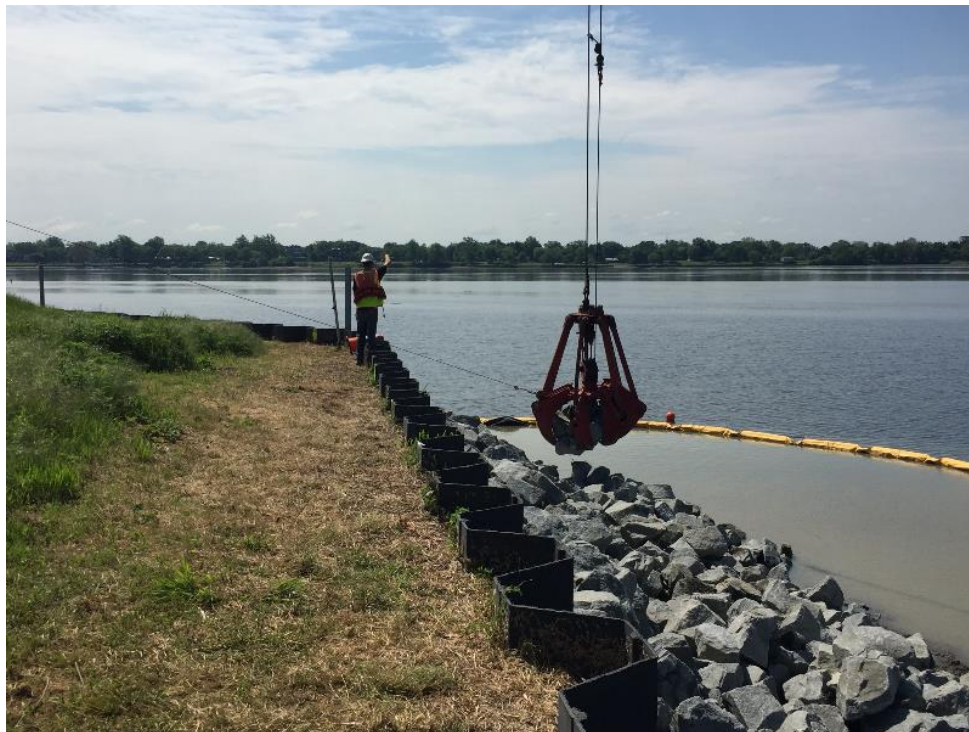
Photo 6: R6 material placement via crane, assisted by CEI spotter, facing east.

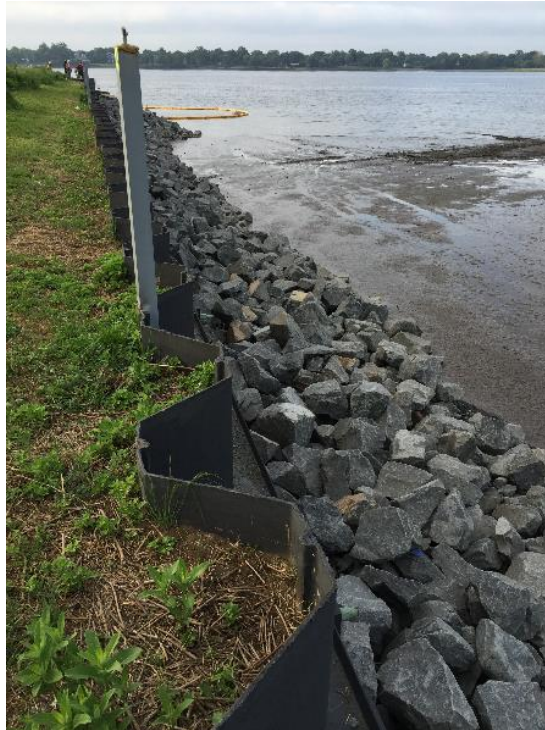
Photo 7: Extent of R6 material placement along southern sheetpile wall (Zone 1), facing east.

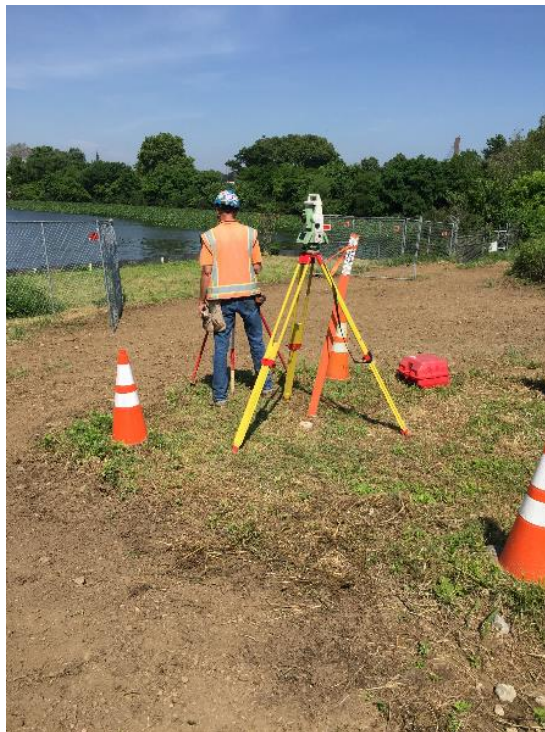
Photo 8: Site surveyor conducting upland survey of sheetpile wall targets, facing southwest.

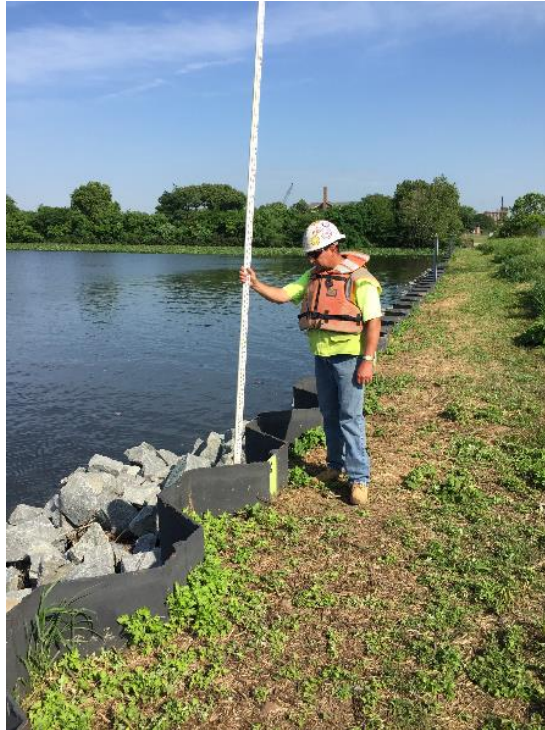
Photo 9: Site surveyor conducting material placement survey, facing west.

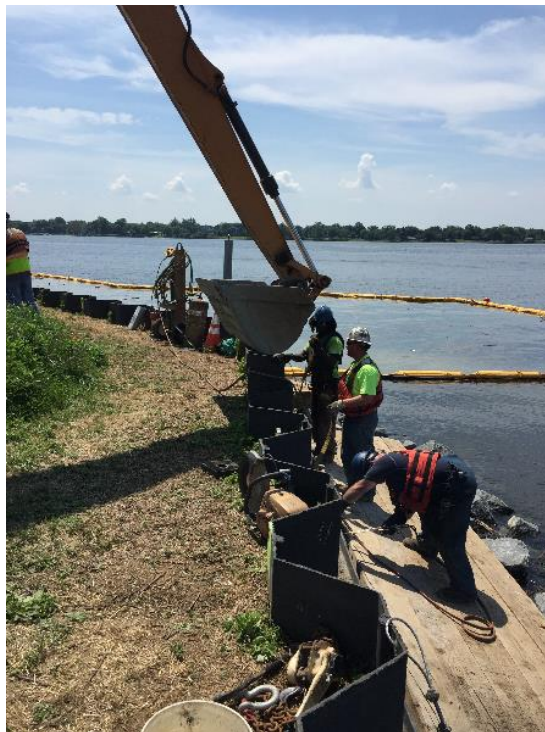
Photo 10: Dock welders prepping for removal of old waler section, facing northeast.

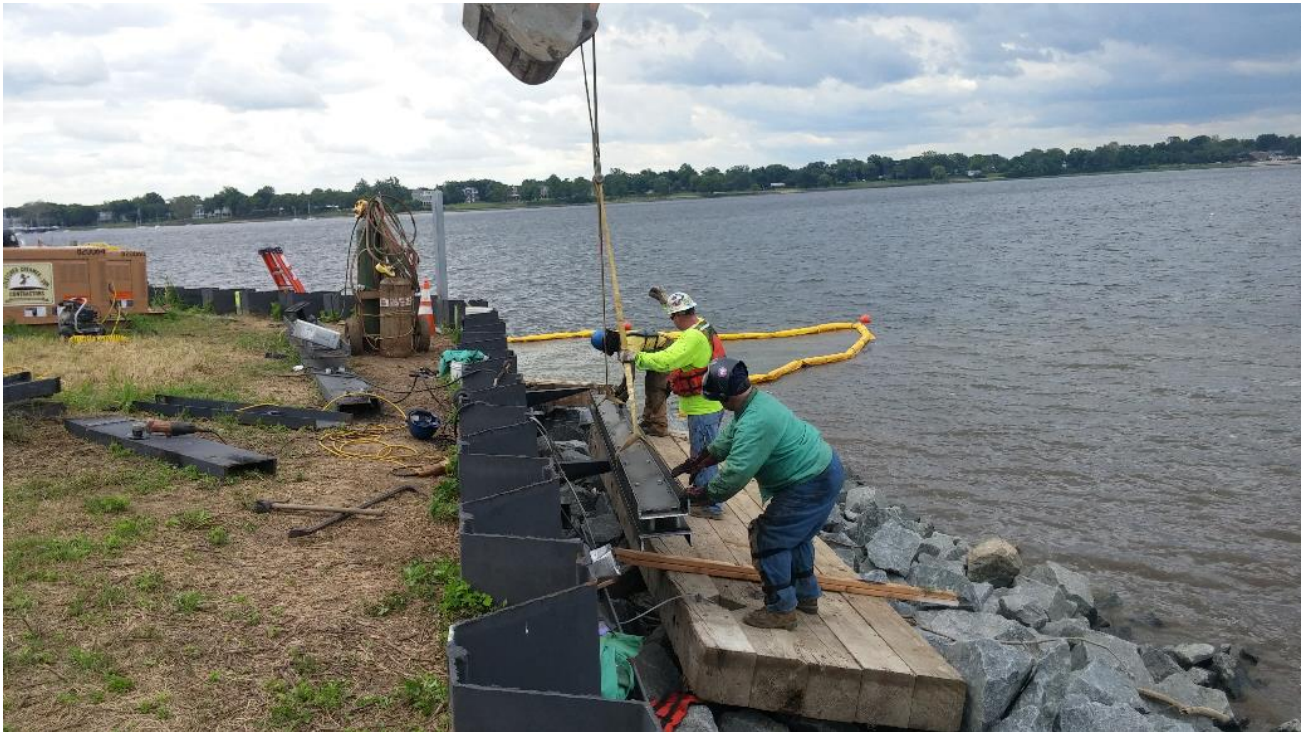
Photo 11: Dock welders positioning new waler section already prepared for installation, facing northeast.

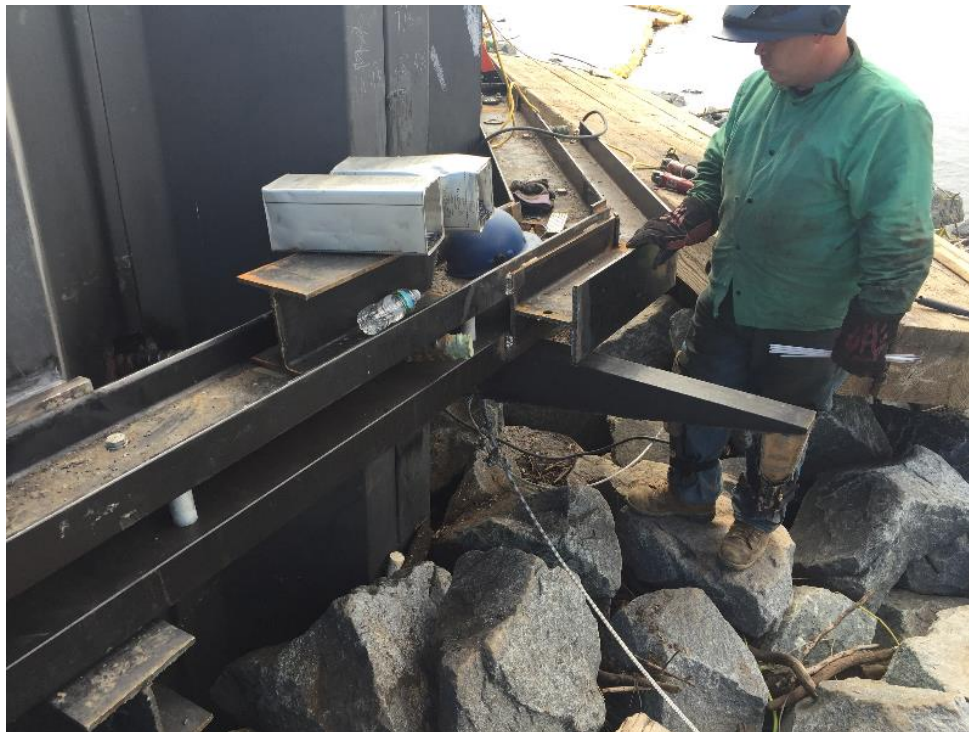
Photo 12: Dock welders continuing final fabrication and installation of HP8 segments, facing north.

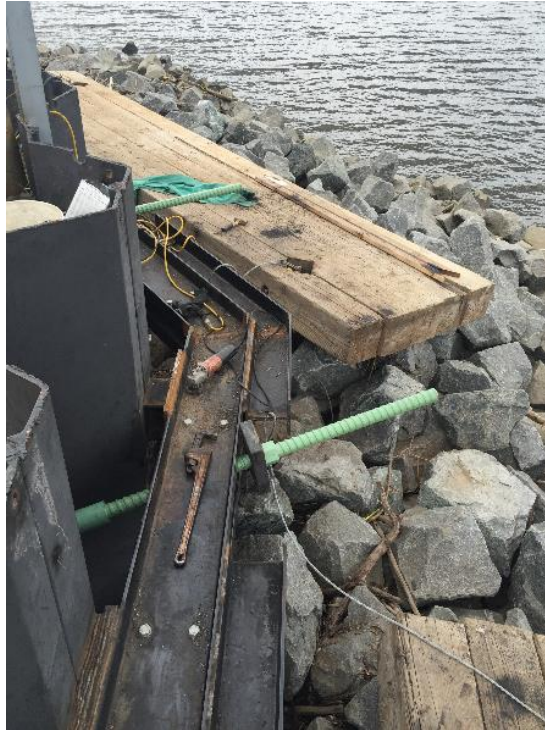
Photo 13: View of repaired water section, HP8 segments, tie-rod extensions, and pack-outs, facing east.

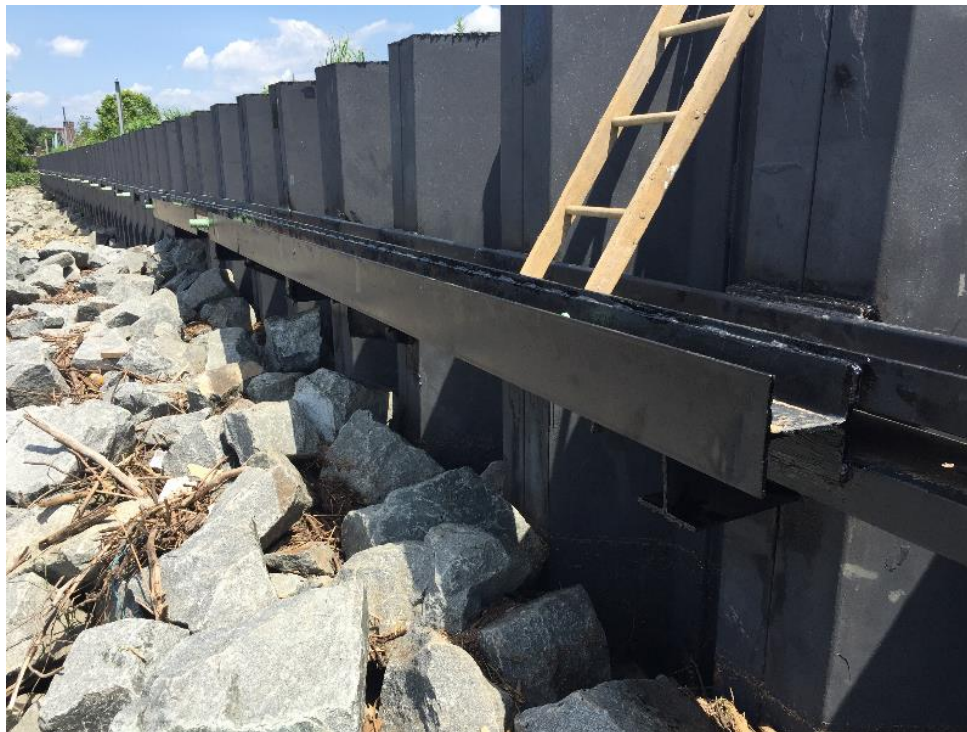
Photo 14: New HP8 segments along sheetpile wall, facing west.

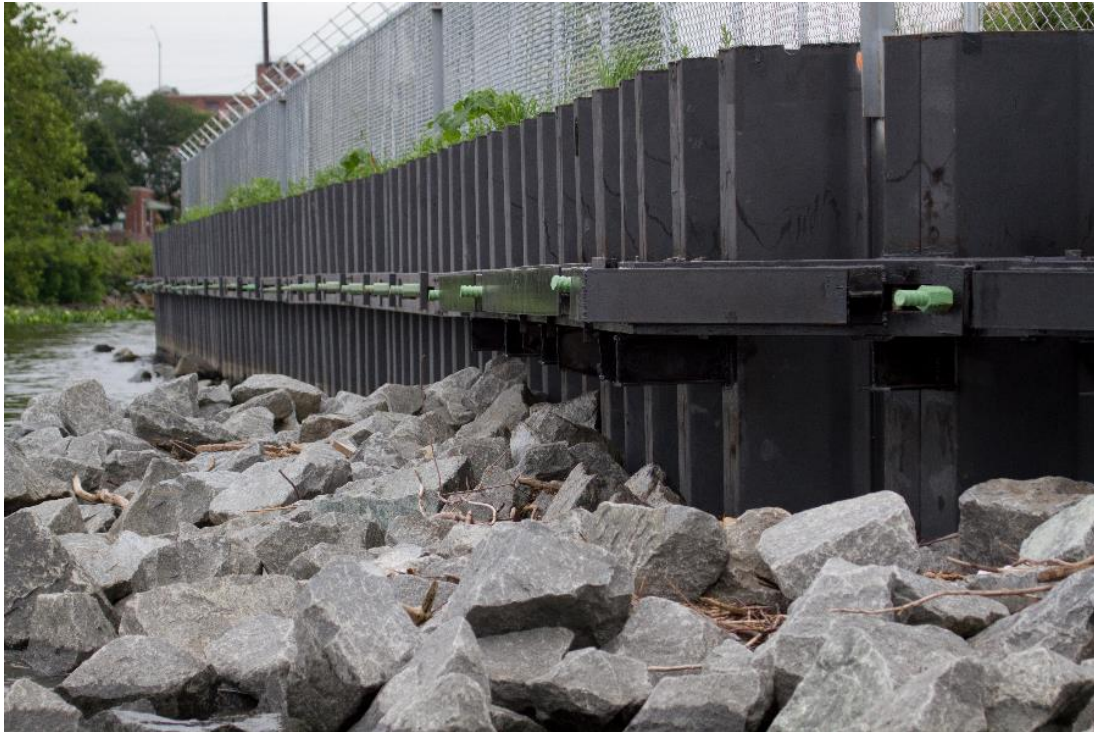
Photo 15: View of completed water repair area and HP8 segments, facing northwest.

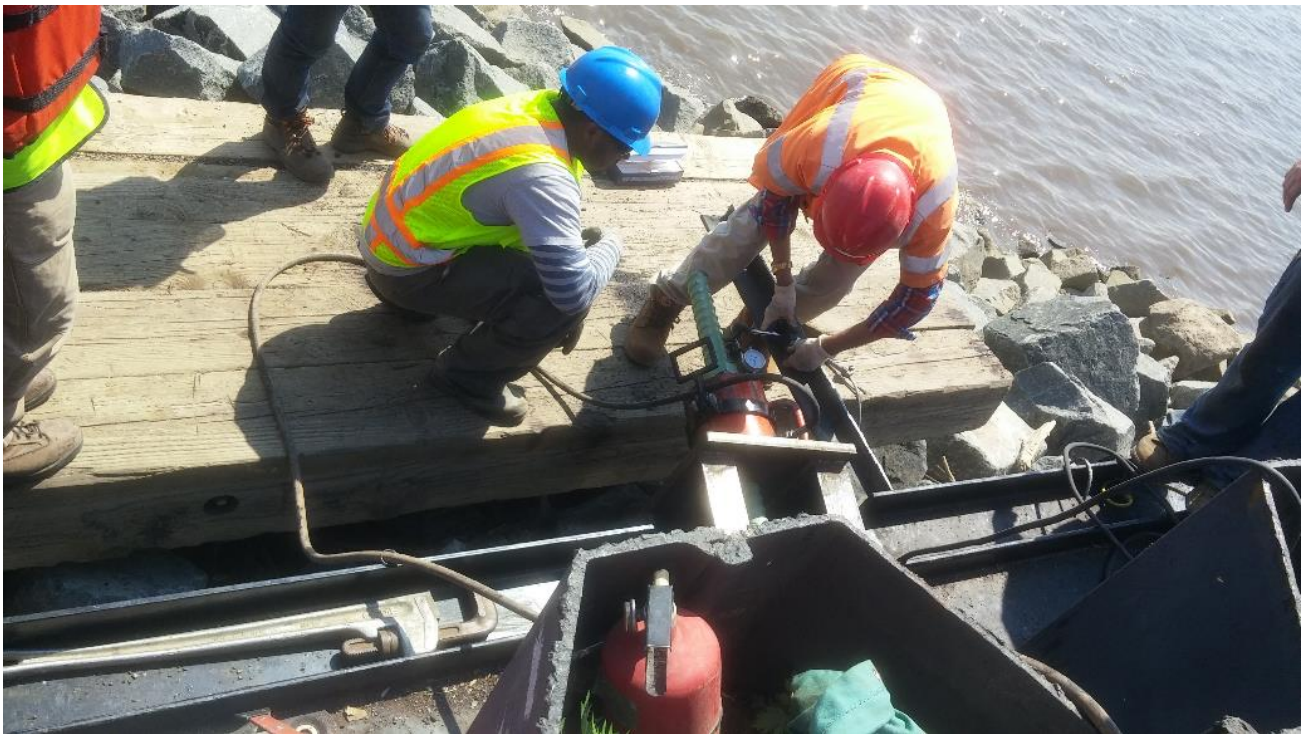
Photo 16: Contractors performing tie-rod stress tests, facing southeast.

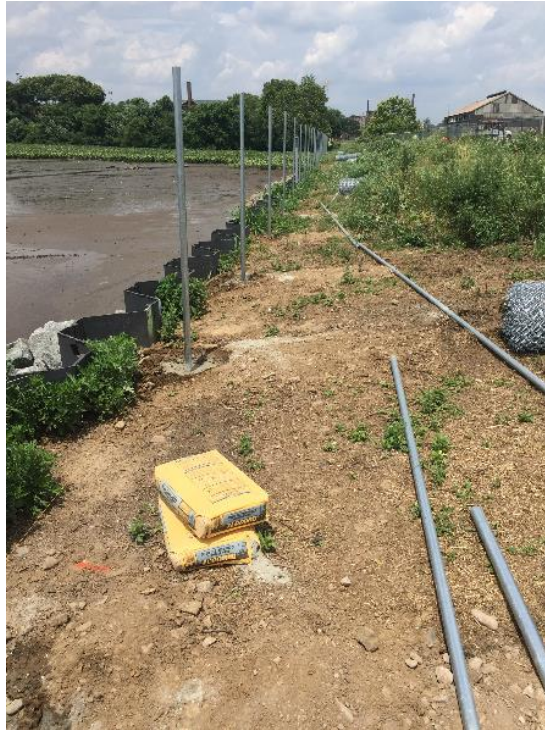
Photo 17: Installation of perimeter fencing along sheetpile wall, facing west.

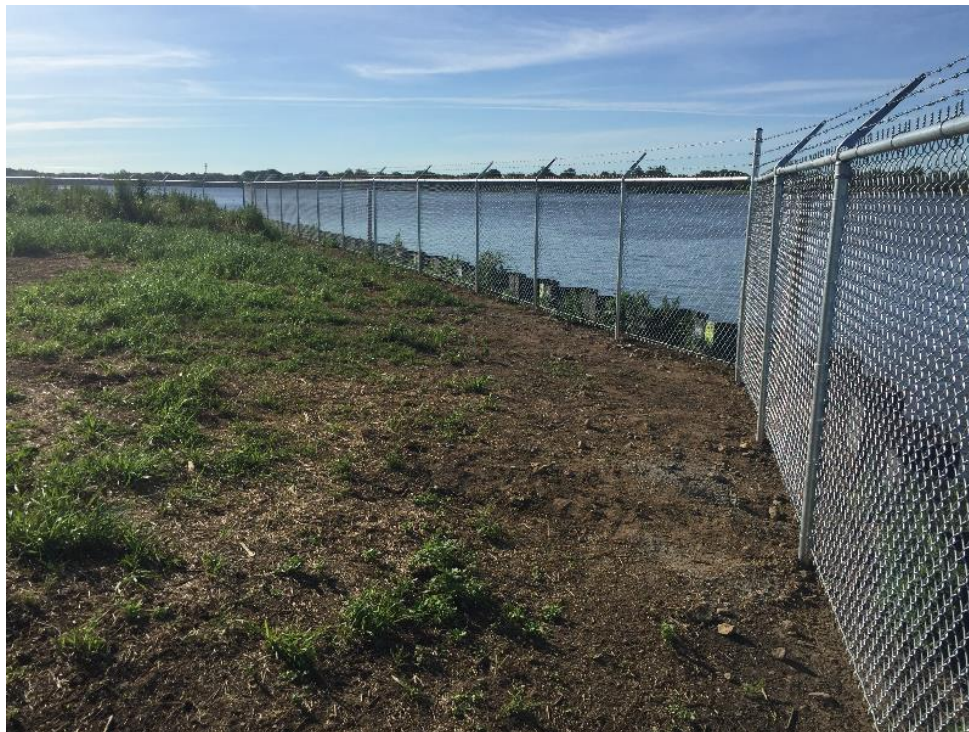
Photo 18: View of completed perimeter fence, facing northeast.

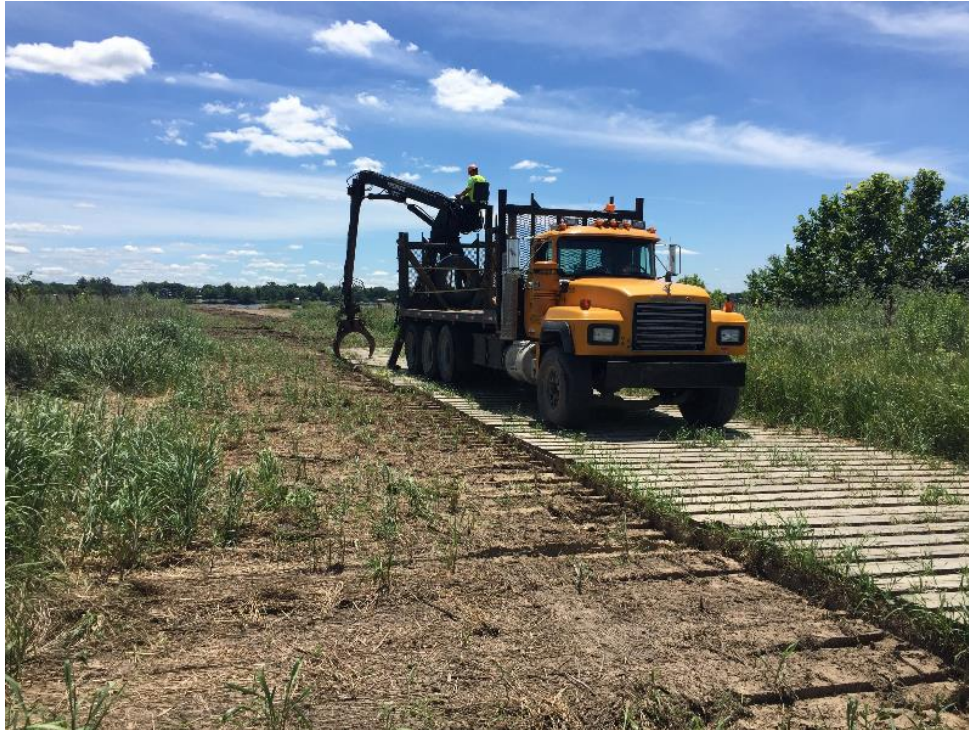
Photo 19: Site restoration; removal of Reese mats which formed the site access road, facing east.

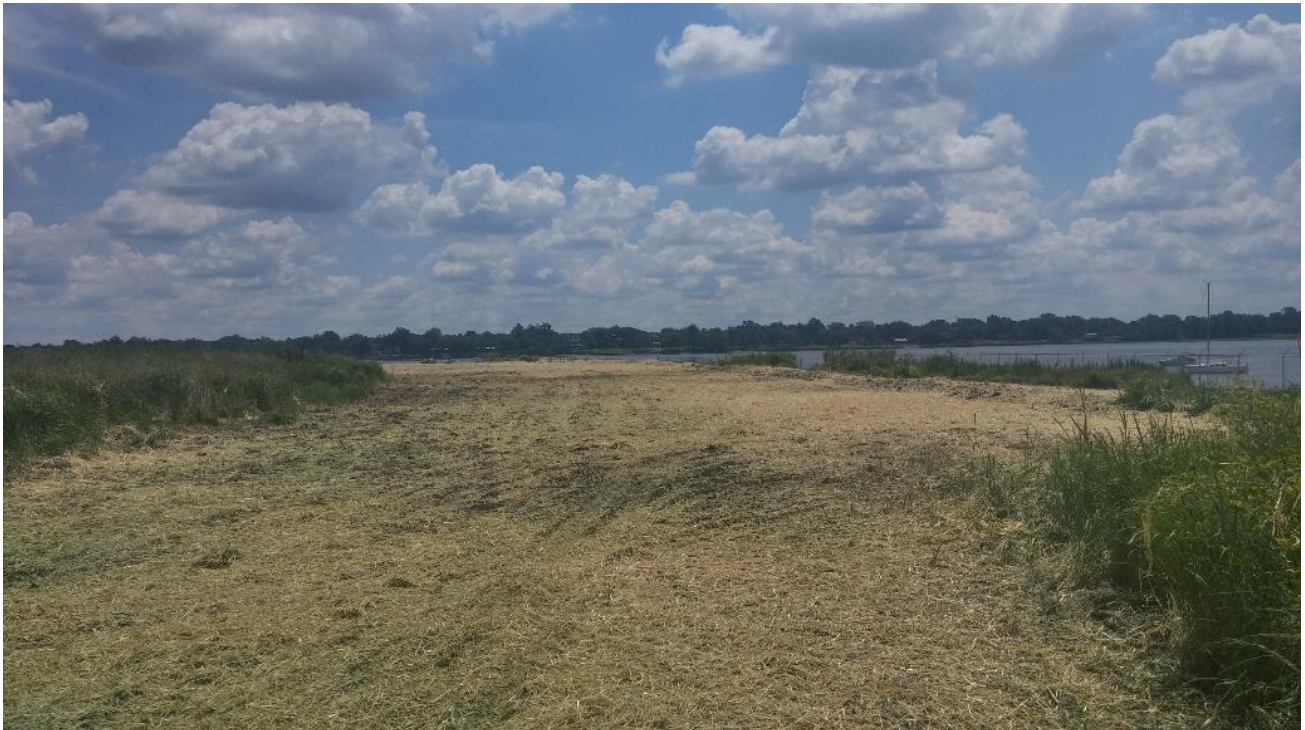
Photo 20: Site restoration; completed revegetation efforts (seeding) across disturbed areas of site, facing east.
